Melody

Major Refit 2008/9

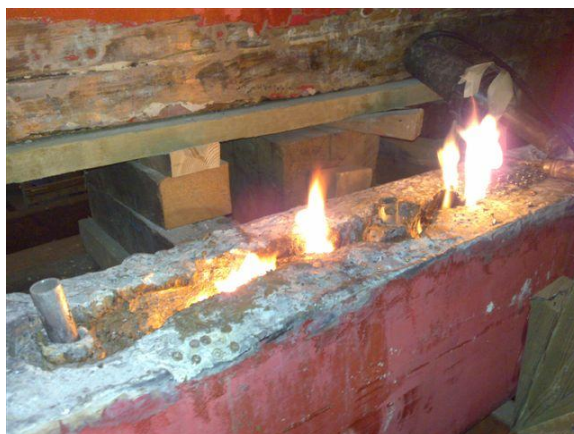
The keel bolts, which could well be original, were all in good shape. It was, however, a surprise to find a large hollow in the centre of the lead running almost the length of the keel presumably due to air bubbles when it was first cast. To rectify this defect a considerable quantity of replacement lead were added to bring the top surface flush.

Pouring New Lead into Hollow Ballast Keel

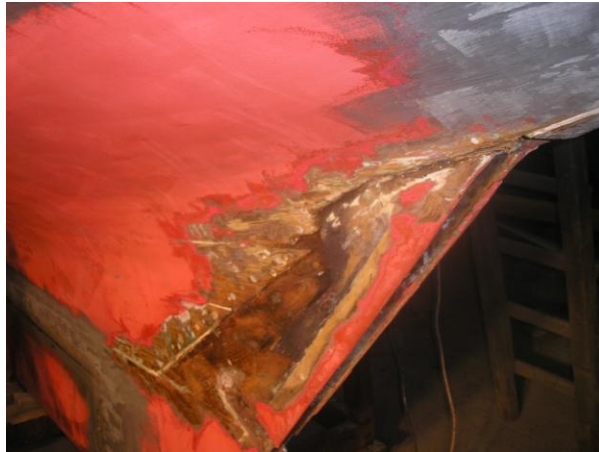
In March serious rot was found in the horn timber near the point where the rudder post passes through it and an area of the hull under the stern was distorted.

Exposed Rotten Horn Timber and Deadwood From Below

Shipwright work was undertaken by Andrew Oliver in his workshop at Aldsworth. This big task involved removing covering boards and the after deck including all internal bulkheads and rigging, rudder and stock, supporting the vessel and making templates of the hull before cutting through all timbers and removing floors in the area. The damaged structural member was cut and dropped out before a newly fashioned horn timber offered up from below. 2 new laminated floors were made and all the remaining timbers

rejoined to the horn by scarfing in new lengths. It was found necessary to replace rotting wood in the deadwood aft of the keel by fabricating a new one. Finally fitting a new deck aft and covering boards completed this part of the work.

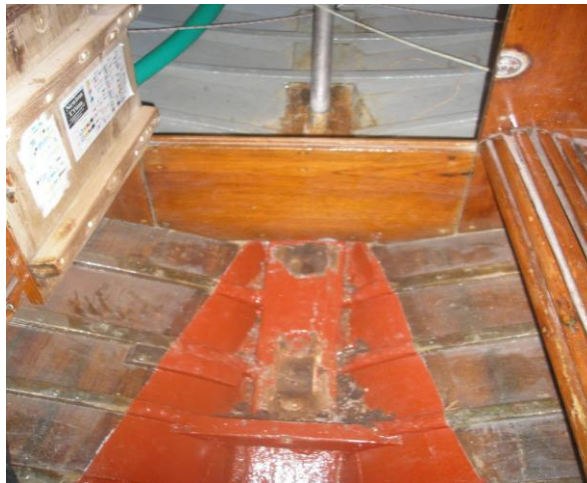
View of Horn Timber From Inside

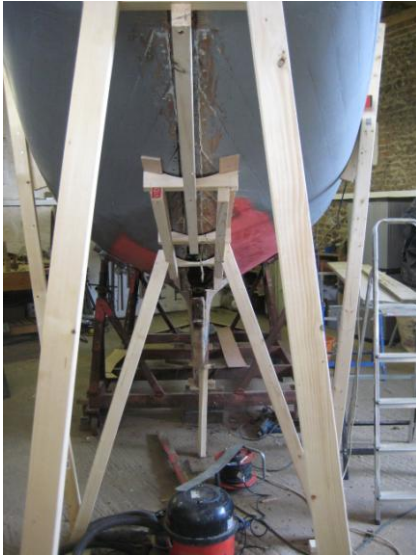
Framework Supporting Stern

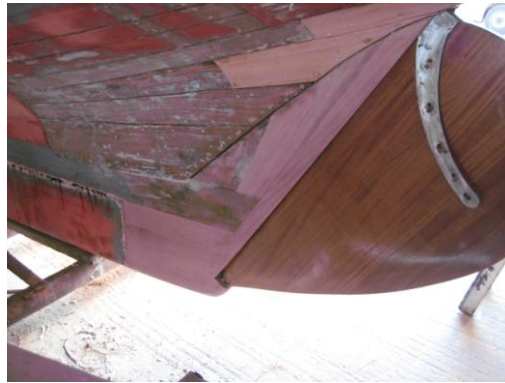
New planking deadwood and Rudder

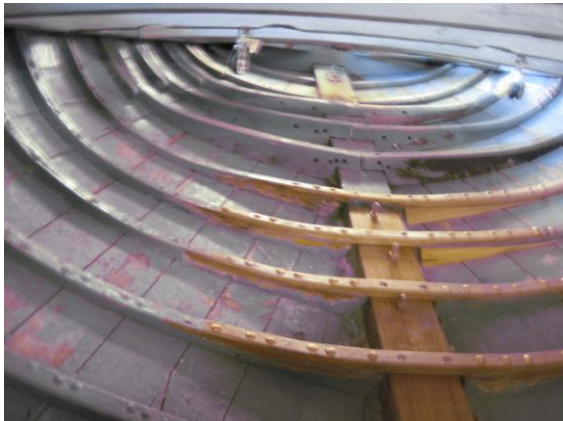
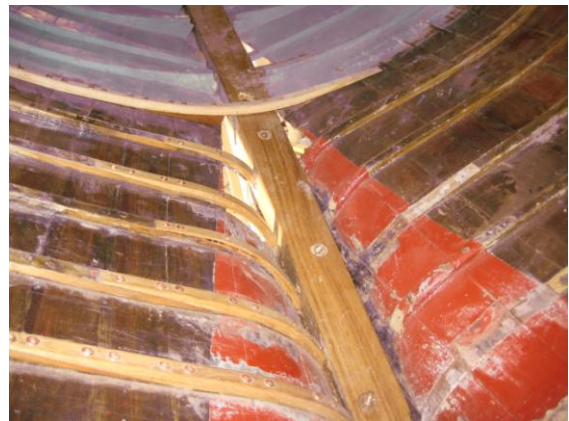
New Horn Timber and Bent Frames

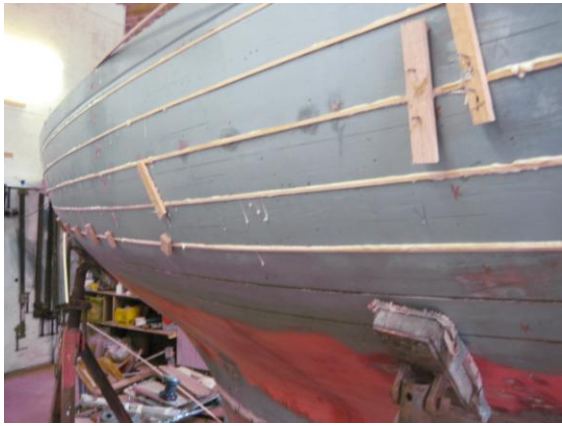
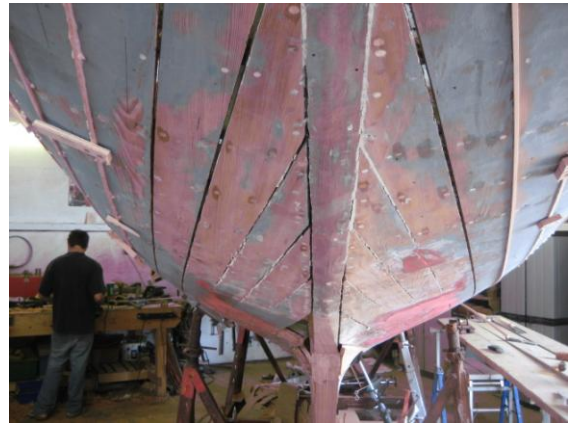
Splined Topsides

Opportunity was also taken while the boat was ashore to spline 7 planks down to the waterline and strengthen under deck particularly in the area of the mast.
